FINAL LANDSLIDE INVESTIGATION REPORT

INVESTIGATION OF SLOPE FAILURE AT TAMAN BUKIT MEWAH,
BUKIT ANTARABANGSA, HULU KLANG, SELANGOR

6 DECEMBER 2008

Volume I: Main Report

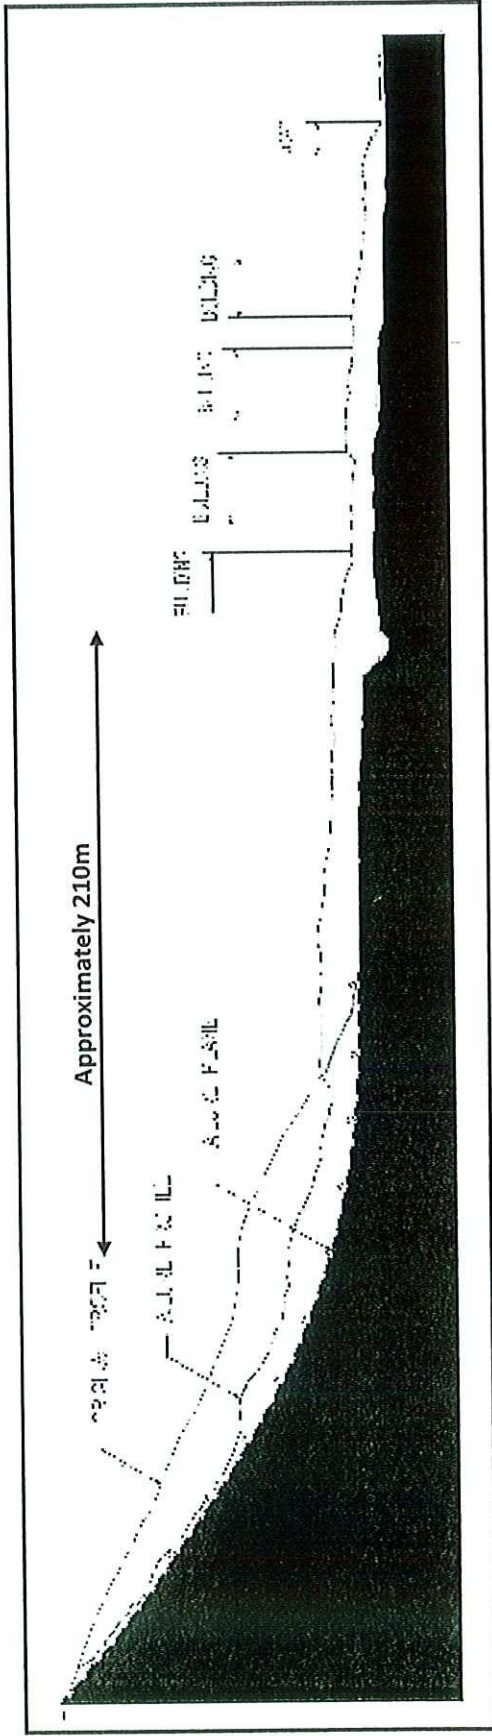
Figure 2: Cross-Section showing the estimated failure plane and failure run-out distance of 210m (as defined in the figure).

On 6th December 2008, a landslide was reported at Taman Bukit Mewah, Bukit Antarabangsa, Hulu Kelang, Selangor (see **Figure 1**). The landslide took place at approximately 3.30 a.m., measuring 109m in width at the crest, 120m in length, 15m in depth and the angle of the scarp of the crown ranges from 45° to 50°. It was estimated that 101,500 cubic meters of earth had translated and the maximum run out distance of the failure debris was measured at approximately 210m from the toe of the slope (see the cross-section in **Figure 2**).

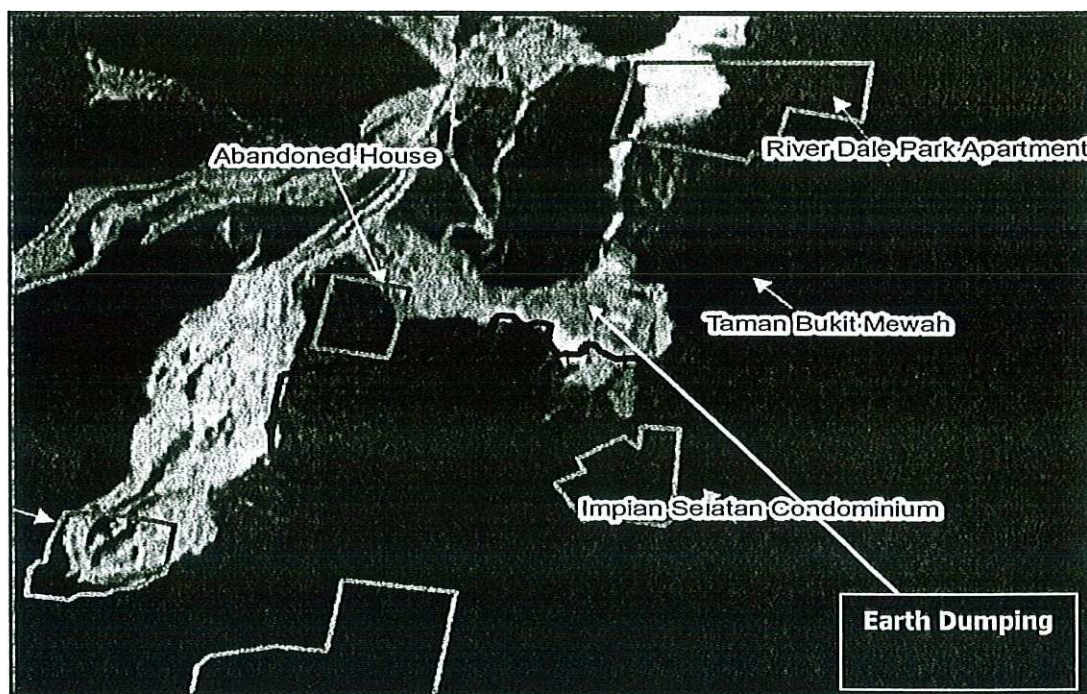
Figure 7c: Aerial photograph taken in 1975

Based on the aerial photographs (1974 and 1975), it is quite clear that there had been massive earthworks' activity at the crest of the failed slope. The aerial photograph taken in 1975 also shows signs of earth dumping around the perimeter of the landslide (see **Figure 7b** and **7c**). In general, the earth dumping was not compacted and loose in nature.

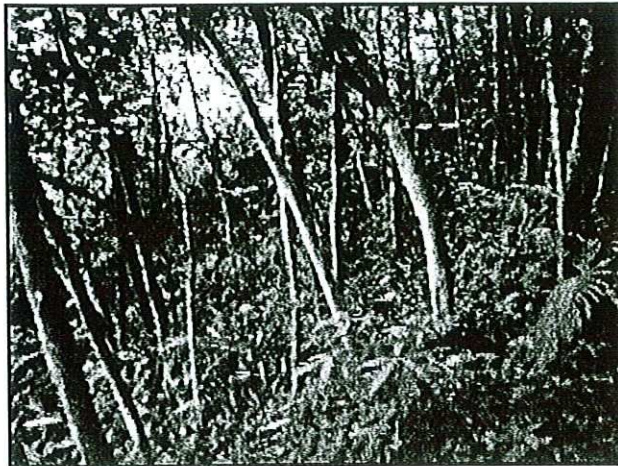
Figure 13a:

From the geomorphological map produced from the Ulu Klang Ampang Hazard Assessment Study, it is clear that the soil at the landslide location was creeping and showing signs of instability. **Figures 13a to 13c** show signs of soil creep before the landslide incident.

Trees leaning on the slope

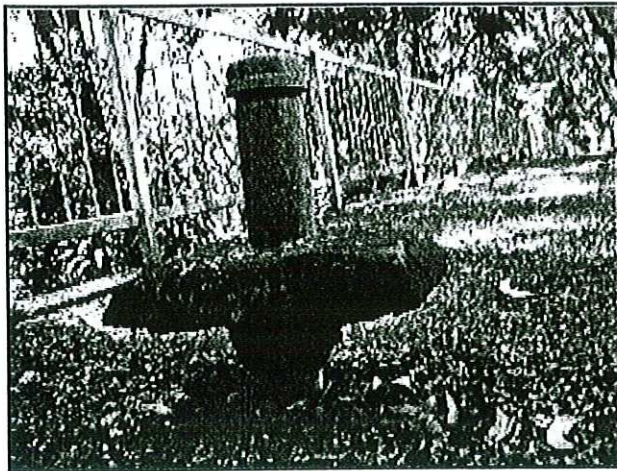
Figure 13b:

Signs of settlement and creep at the crest of the slope

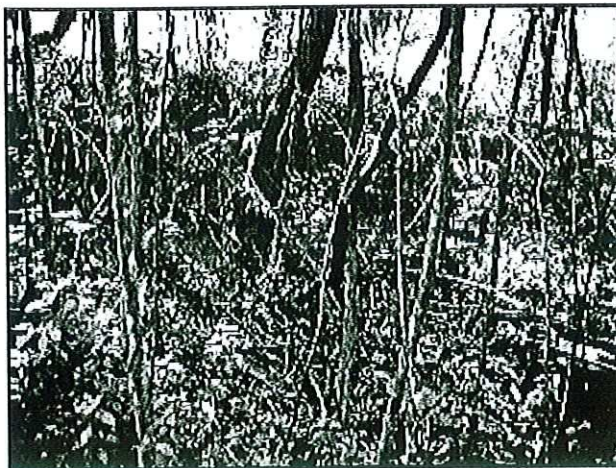
Figure 13c:

Shallow slips were noted at the toe of the slope before failure.

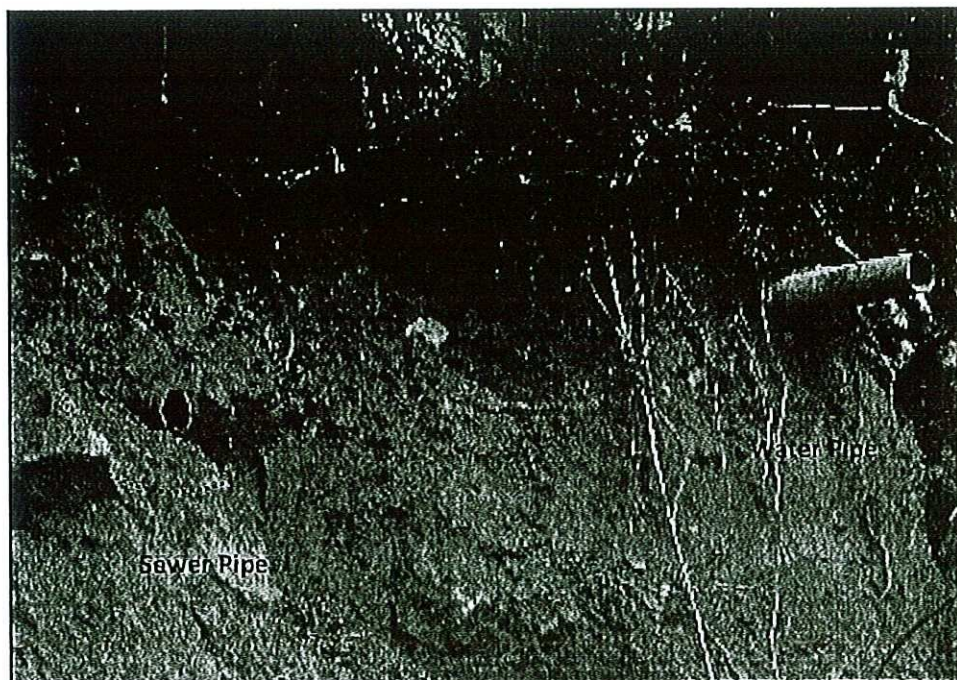
Plate 3 (Photo 13 in Appendix C)

From the water reticulation plan, it was understood that there was an active asbestos cement (AC) water pipe of 215mm in diameter running across the slope into the abandoned houses. The damaged water pipe can be clearly seen on the failure scar (refer **Photo 13** in **Appendix C**).

- c) Near the abandoned houses, the failure exposed a damaged water pipe of 215mm in diameter and sewerage pipes. (Refer to **Plates 3 and 4: Photos 13 and 14** in **Appendix C**). These exposed pipes were located underneath the nearby abandoned houses.

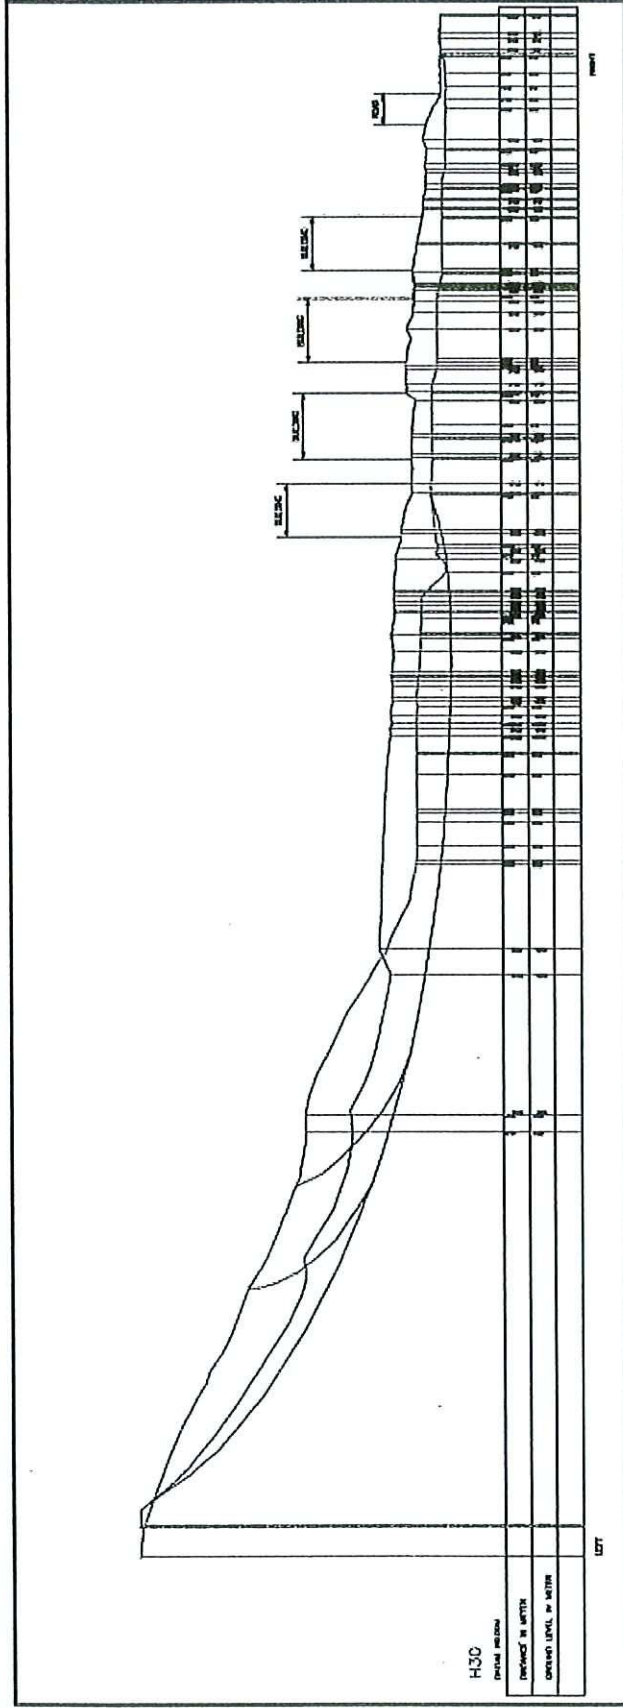
Figure 18: Cross section extracted from TLS and LIDAR showing the 3 (three) slumps

The cross-sections extracted from TLS indicate that at least three (3) slumps were involved in the landslide (see **Figure 18**). It is believed that the lower berm of the slope gave way first followed by the second and third slumps above due to over steepening. This mechanism of failure concurs with some eyewitness accounts of three (3) loud crashing sounds during the landslide event within a space of 3 to 5 minutes. Furthermore, based on the eyewitness accounts, the first loud crash resulted in the displacement of the houses to the main road (Jalan Bukit Antarabangsa). The second and third crashes (the second and third slumps) resulted in the debris and houses to be displaced further.

The ratio of the failure depth (approximately 15m) and the slope length (120m) was found to be greater than 0.1, thus the failure can be classified as deep-seated. Such a failure is usually governed by ground water and/or high pore water pressure within the slope (Othman, Dr M.A. et al, 2001).
