# **RADON DIAGNOSTIC TESTING**

## **UNITED STATES ARMY GARRISON SCHWEINFURT, GERMANY**

### **FINAL REPORT**

**February 2008**

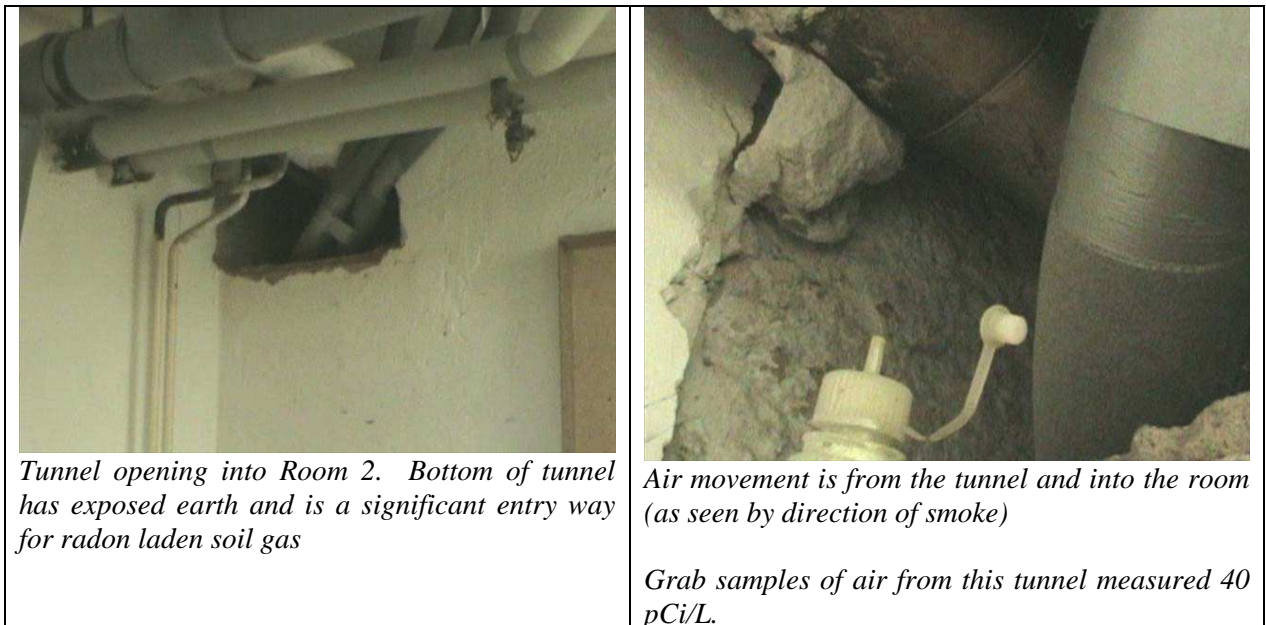
**Figure 18: Tunnel Opening Bldg 503**

Soil Gas at V1: 301 pCi/L  
 Soil gas from Tunnel: 40 pCi/L

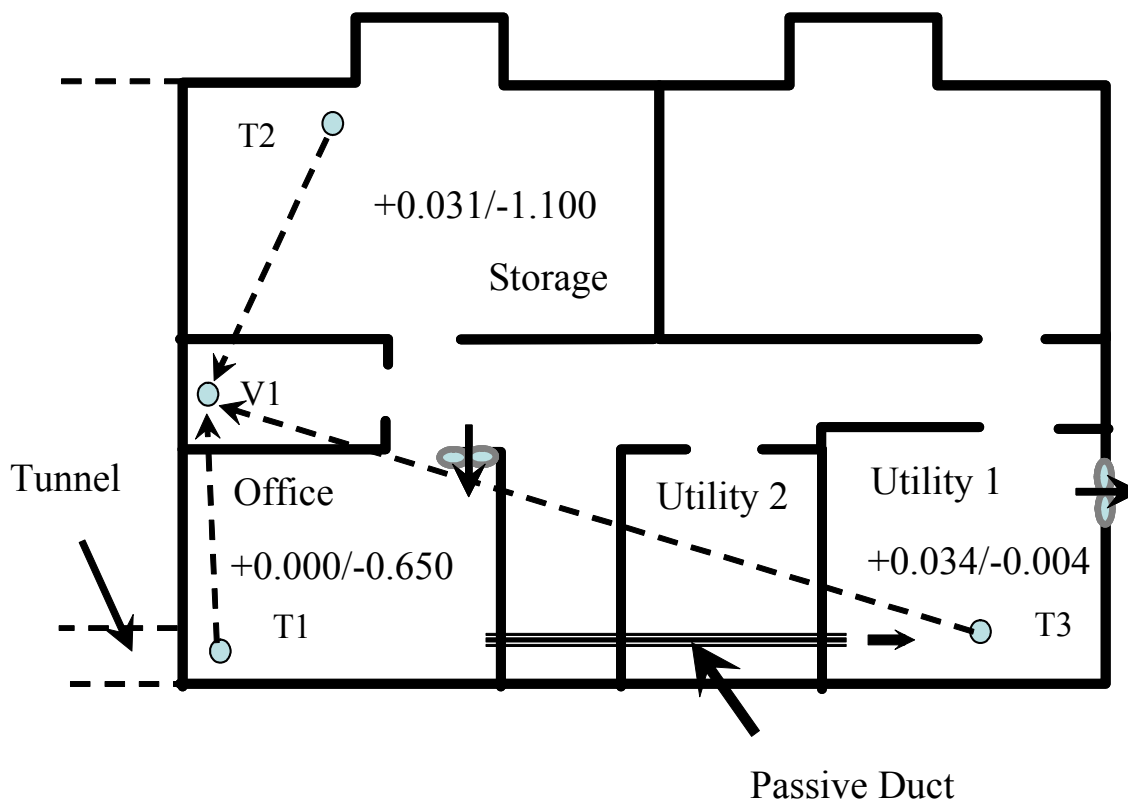
**Figure 19: ASD Diagnostics Bldg 503**

A larger hole was drilled at V1 and the suction wand of a shop vacuum was temporarily connected to the subgrade at this point and the resultant negative pressures that were imparted at locations T1, T2 and T3 were measured. The results of this are shown in Figure 19 below and clearly indicate that a single point active soil depressurization system would have the ability to create substantial negative pressures under the entire foundation and adequately reduce radon throughout the entire basement area (provided exhaust fan in utility room is disabled).

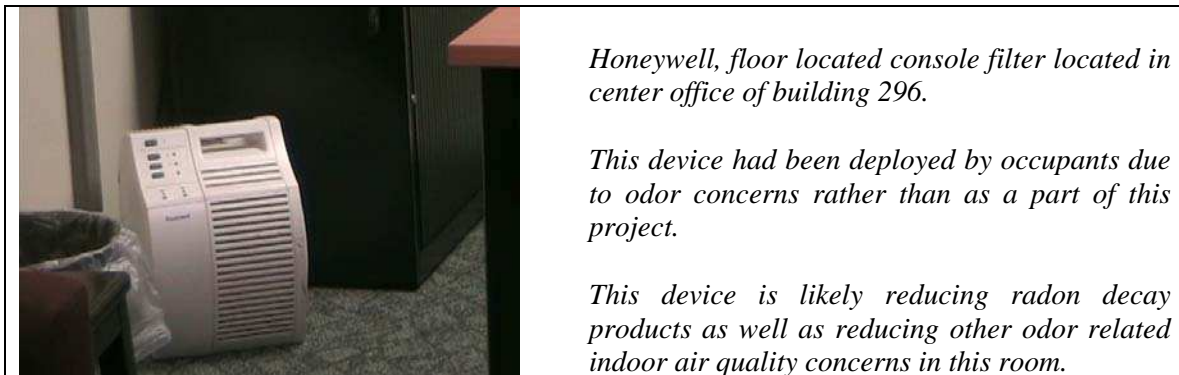
**Figure 20: Air Purifier Located in Office of Building 296**

It is likely that this portable device is reducing radon decay products, but an assessment of this could not be performed as such specialized testing equipment was not available at the time of the investigation.

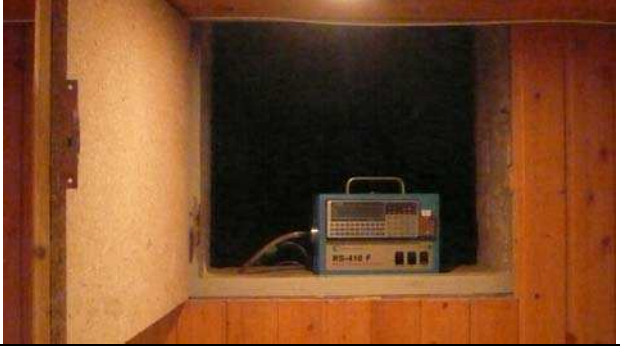
<p><i>Access door into crawlspace opened.</i></p> <p><i>Grab sample device located in opening before door closed and sample taken.</i></p> <p><i>Access doors can only be opened with a special key, which both occupants had in their possession.</i></p>

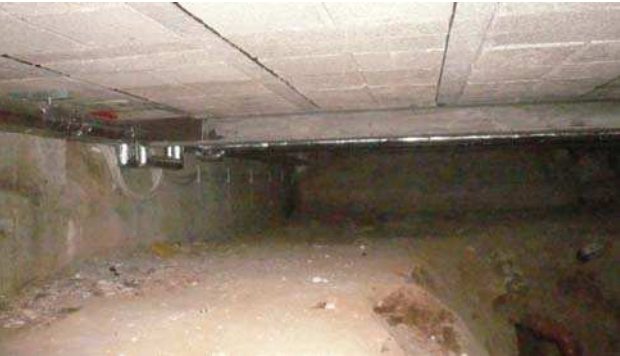
<p><i>View of earthen crawlspace.</i></p> <p><i>Note concrete decking above crawlspace are precast sections with gaps between the sections that would allow radon to migrate to first floor area in addition to the basement.</i></p> <p><i>Earthen area is uneven in the two locations viewed, with a deeper area near the interior footing all the way to the near the footing line.</i></p> <p><i>Utilities enter from one end of crawlspace (back left portion of photo)</i></p>

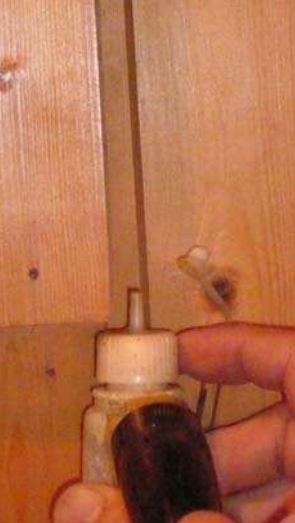
<p><i>Opening around crawlspace access door showed air flow direction to be from crawlspace into basement.</i></p> <p><i>Micromanometer readings across crawlspace doors measured positive 0.002 inches WC within the crawlspace relative to basement interior.</i></p> <p><i>With elevated radon levels in crawlspace and the passage of air from crawlspace into living space, these areas are major radon entry points.</i></p>
