FINAL LANDSLIDE INVESTIGATION REPORT

INVESTIGATION OF SLOPE FAILURE AT TAMAN BUKIT MEWAH,
BUKIT ANTARABANGSA, HULU KLANG, SELANGOR

6 DECEMBER 2008

Volume I: Main Report

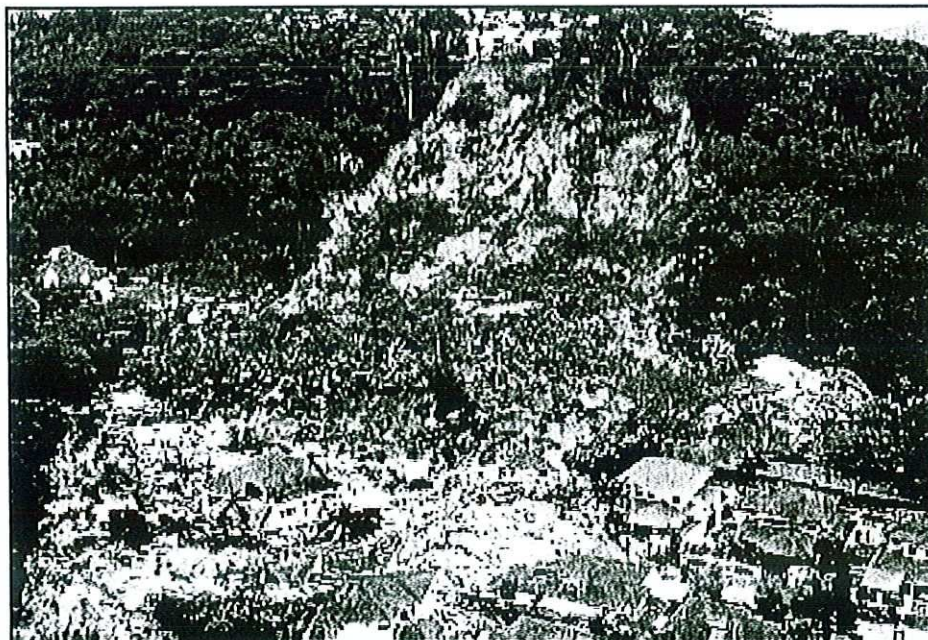
Figure 1: Overall view of the landslide location

On 6th December 2008, a landslide was reported at Taman Bukit Mewah, Bukit Antarabangsa, Hulu Kelang, Selangor (see **Figure 1**). The landslide took place at approximately 3.30 a.m., measuring 109m in width at the crest, 120m in length, 15m in depth and the angle of the scarp of the crown ranges from 45° to 50°. It was estimated that 101,500 cubic meters of earth had translated and the maximum run out distance of the failure debris was measured at approximately 210m from the toe of the slope (see the cross-section in **Figure 2**).

The landslide debris completely blocked Jalan Bukit Antarabangsa, the only road access to some other 5000 residents. Fourteen (14) bungalow houses were destroyed by the failure debris. The landslide also resulted in five (5) fatalities and injury to fourteen (14) others.

An area of approximately four (4) hectares of land was affected. The affected areas were Taman Bukit Mewah, Jalan Bukit Antarabangsa, Jalan Wangsa 11 and Jalan Wangsa 9 of Taman Wangsa Ukay, Jalan Bukit Jaya 6A of Taman Bukit Jaya, Impian Selatan Condominium and Kyoto Garden Condominium.

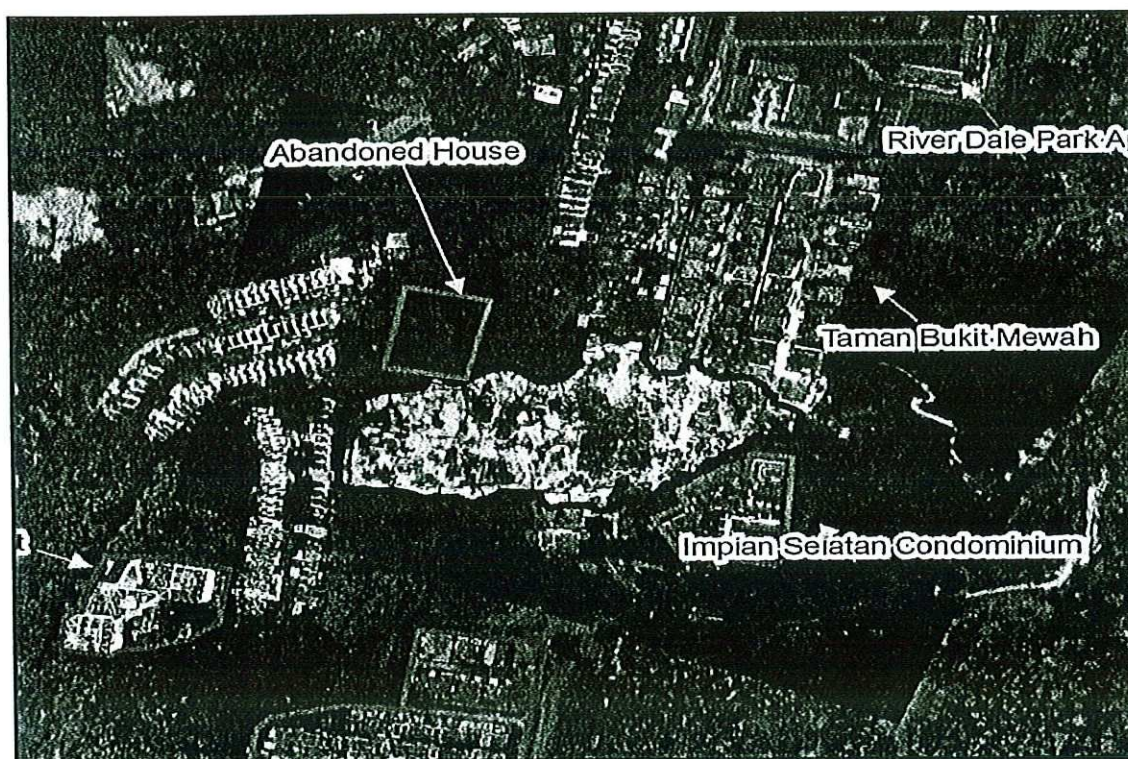
Figure 7i: Aerial photograph taken in 2008

Aerial photographs of 1999, 2003 and 2007 show that thick vegetation had completely covered the areas around the abandoned houses. One (1) row of the abandoned houses can no longer be seen in the aerial photographs as it is probably hidden in the dense vegetation (see **Figures 7f, 7g and 7h**). Aerial photograph of 2008 shows the landslide scar (see **Figure 7i**).

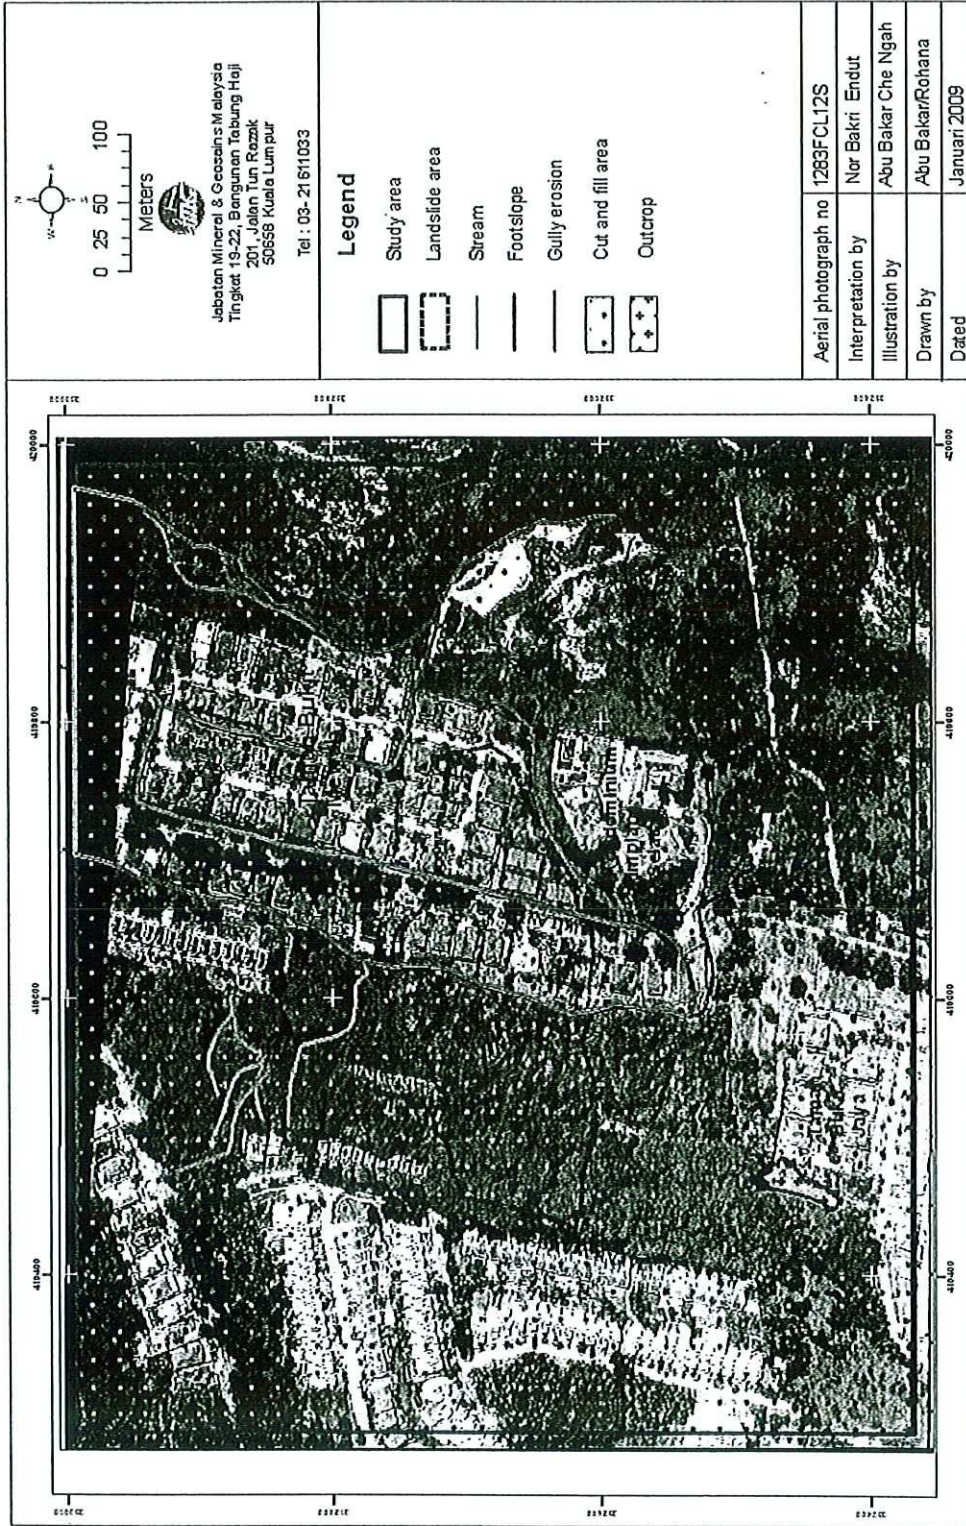
Figure 7p: Aerial photograph taken in 2003

Aerial photograph of 2003 (see **Figure 7p**) shows about the same vegetation formation as the year before. The stream lines that were once

visible in 2002 now had formed gully erosions. The only visible stream line is located at northwestern side of the landslide area.

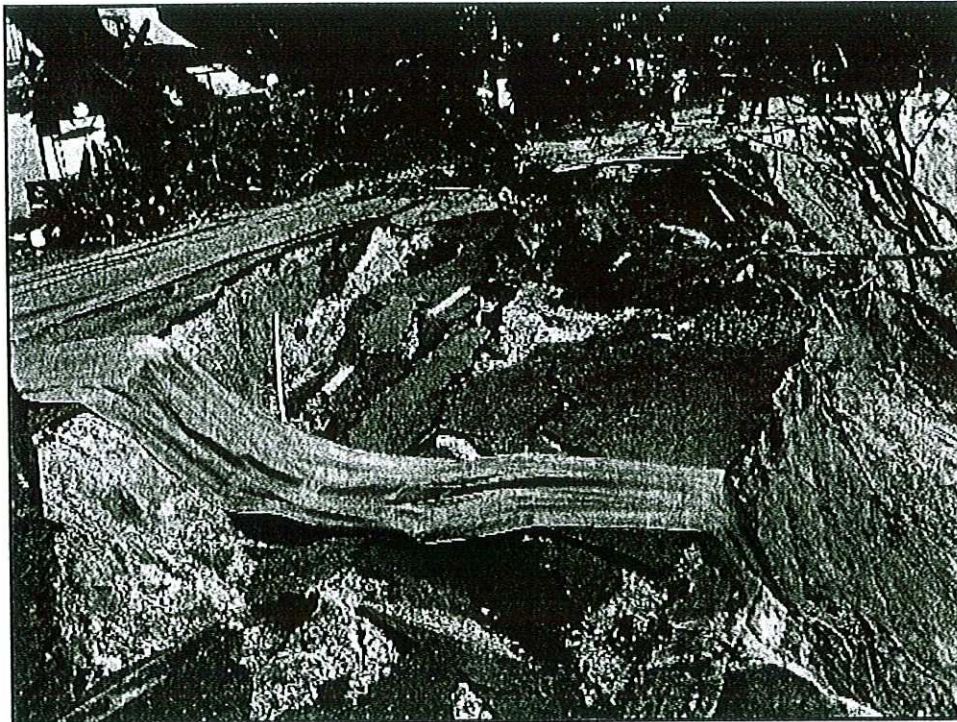
Plate 1 (Photo 1 in Appendix C)

-
- a) Along Jalan Wangsa 9 at the crest of the landslide, a 40m deep headscarp with gradient approximately 45° to 70° was observed. Arcuate cracking was also observed along the longitudinal direction of the road, underneath the temporary protective plastic sheets (refer to **Plate 1: Photo 1** in **Appendix C**)

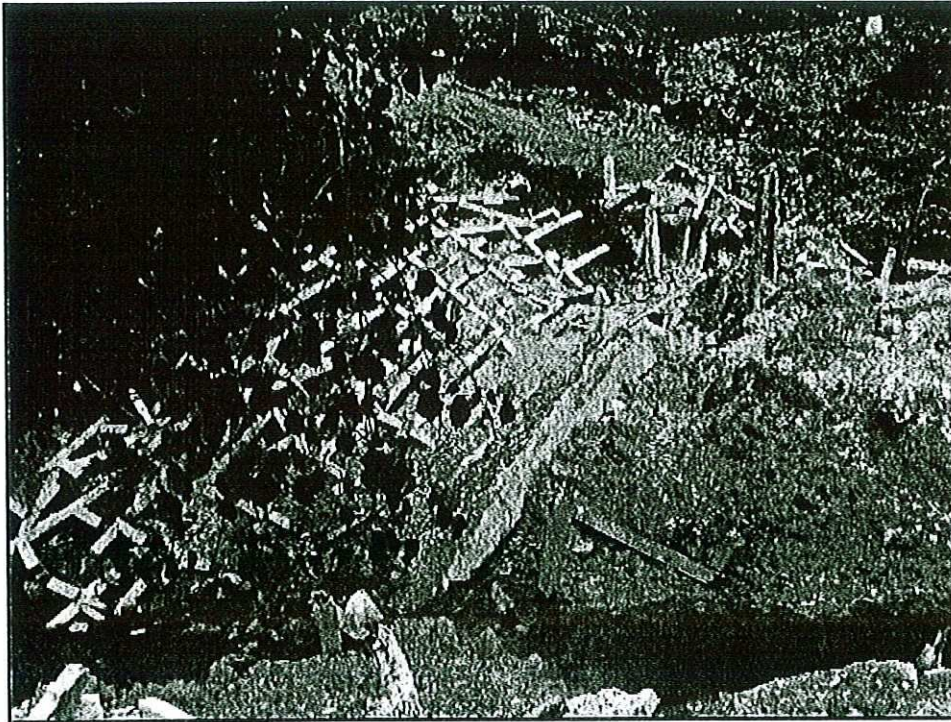
Plate 5 (Photo 12 in Appendix C)

- d) Crib wall elements were found within the failure debris, and it is believed that the crib wall structures were left in the filled slope of the abandoned development (refer to **Plate 5: Photo 12** in **Appendix C**).

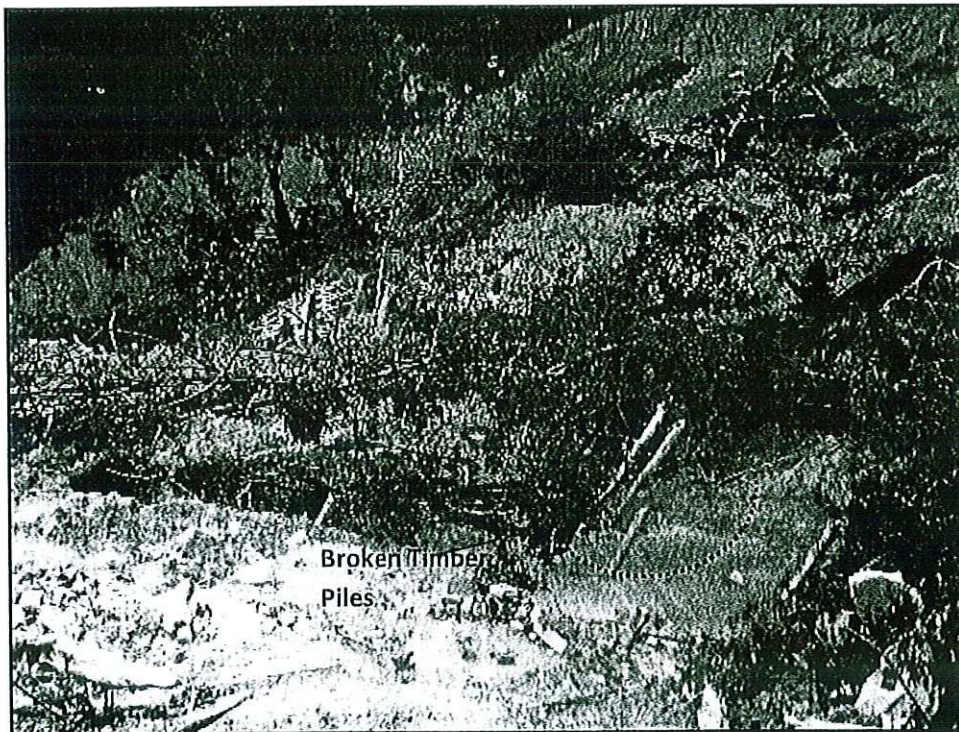
Plate 6 (Photo 7 in Appendix C)

- e) Broken timber piles were discovered in the failure debris. These foundations remnants are believed to have been left within the filled slope of the abandoned development (refer **Plate 6: Photo 7** in **Appendix C**).

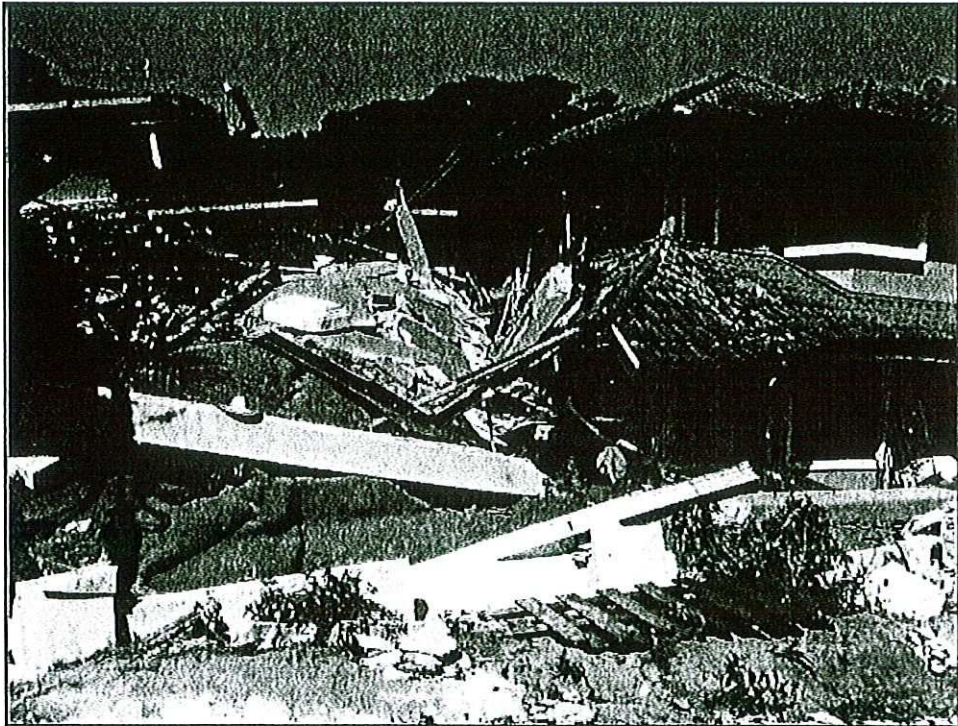
Plate 7 (Plate 18 in JMG's Report)

-
- g) Jalan Bukit Antarabangsa at the toe of the landslide had heaved up more than 1 meter above its original level. Jalan Bukit Mewah also heaved up due to the landslide impact (refer to **Plate 7: Plate 18** in JMG's Report).
 - h) Houses at the toe of the landslide were completely damaged. Some units were found to have been swept away by the failure debris.
 - i) The maximum distance of travel of the failure debris was measured to be approximately 210m from the toe of the landslide.
 - j) A mixture of soil and rock boulders was noted on the failure scar located at the northern corner of the slope toe. This is believed to be dumped or spoiled materials during the development.

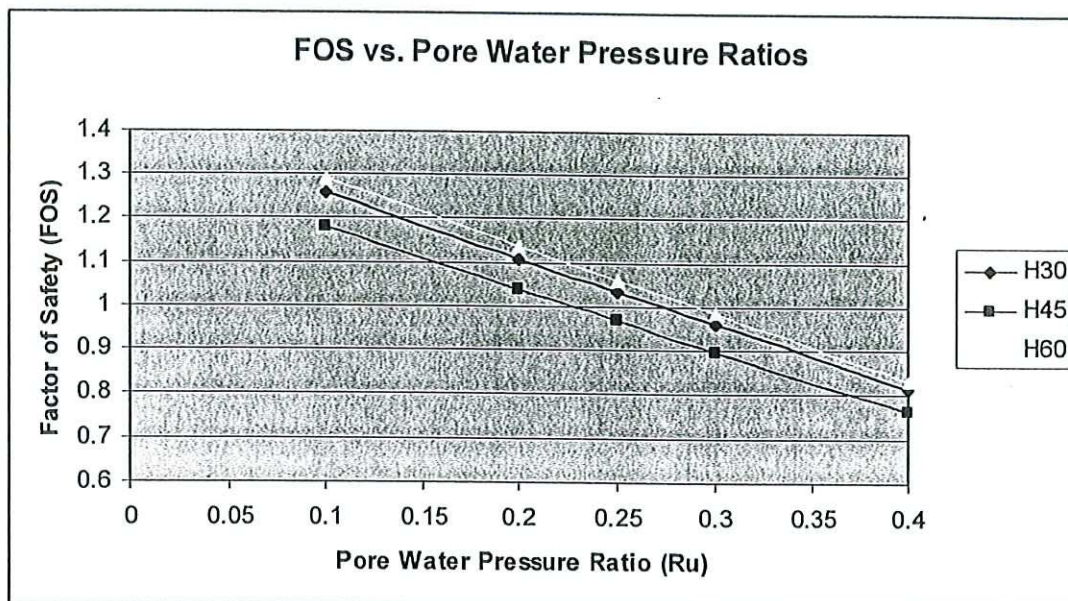
Figure 19: Factor of Safety (FOS) based on Pore Water Pressure Ratios

Ru coefficients	Factor of Safety (FOS)		
	Section H30	Section H45	Section H60
0.10	1.260	1.180	1.293
0.20	1.109	1.038	1.138
0.25	1.034	0.968	1.061
0.30	0.960	0.898	0.985
0.40	0.815	0.762	0.833

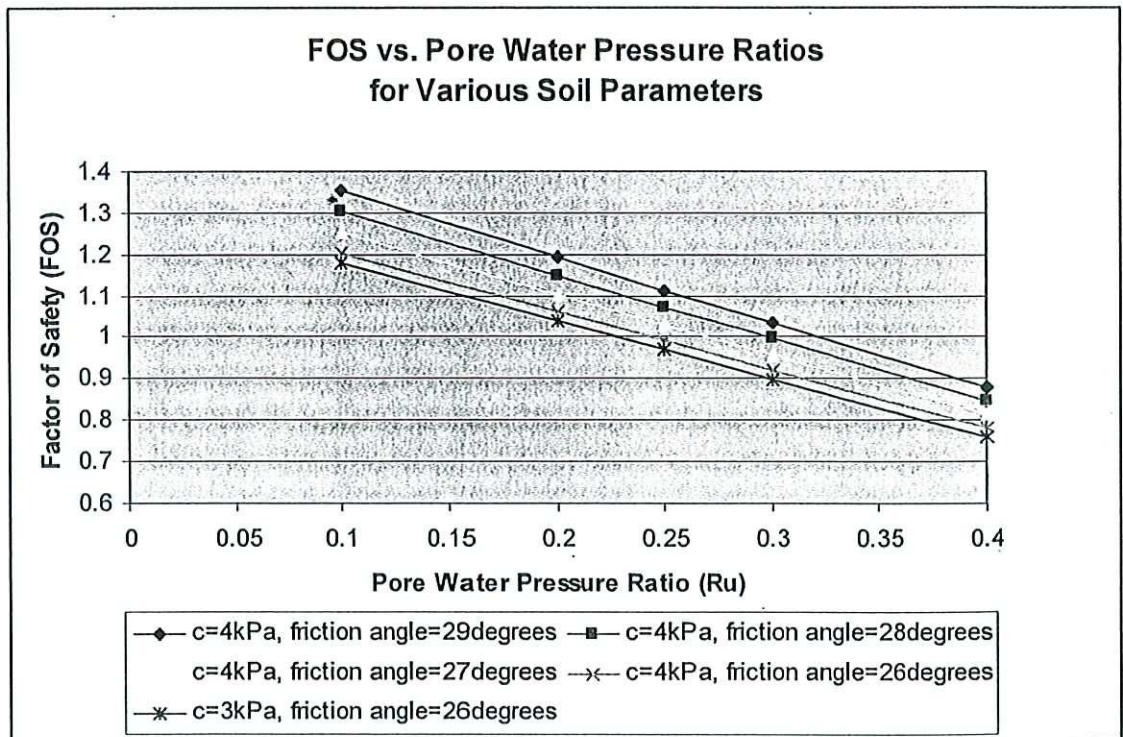
Figure 20: Factor of Safety (FOS) based on Pore Water Pressure Ratios for Various Soil Parameters

Another series of analyses were carried out based on the section H45 as this cross-section passes through in the middle of the failure area (see **Appendix S**). The pore water pressure ratios (Ru) of 0.10, 0.20, 0.25, 0.30 and 0.40 were applied in the analyses of section H45 to obtain the Factor of Safety (FOS) at the toe of the slope (first slump) for various soil parameters. The soil parameters for the non-engineered fill with loose lenses were applied in the range of $c' = 3$ to 4 kPa and $\phi' = 26^\circ$ to 29° . The detailed analyses are shown in **Appendix T**. The results of the analysis are summarized in **Table 13**.

Ru coefficients	Factor of Safety (FOS)				
	c'=4kPa, φ'=29°	c'=4kPa, φ'=28°	c'=4kPa, φ'=27°	c'=4kPa, φ'=26°	c'=3kPa, φ'=26°
0.10	1.355	1.304	1.253	1.204	1.181
0.20	1.193	1.149	1.105	1.062	1.038
0.25	1.114	1.072	1.031	0.991	0.968
0.30	1.034	0.996	0.958	0.921	0.898
0.40	0.879	0.847	0.816	0.785	0.762
