# **RADON DIAGNOSTIC TESTING**

## **UNITED STATES ARMY GARRISON SCHWEINFURT, GERMANY**

### **FINAL REPORT**

**February 2008**

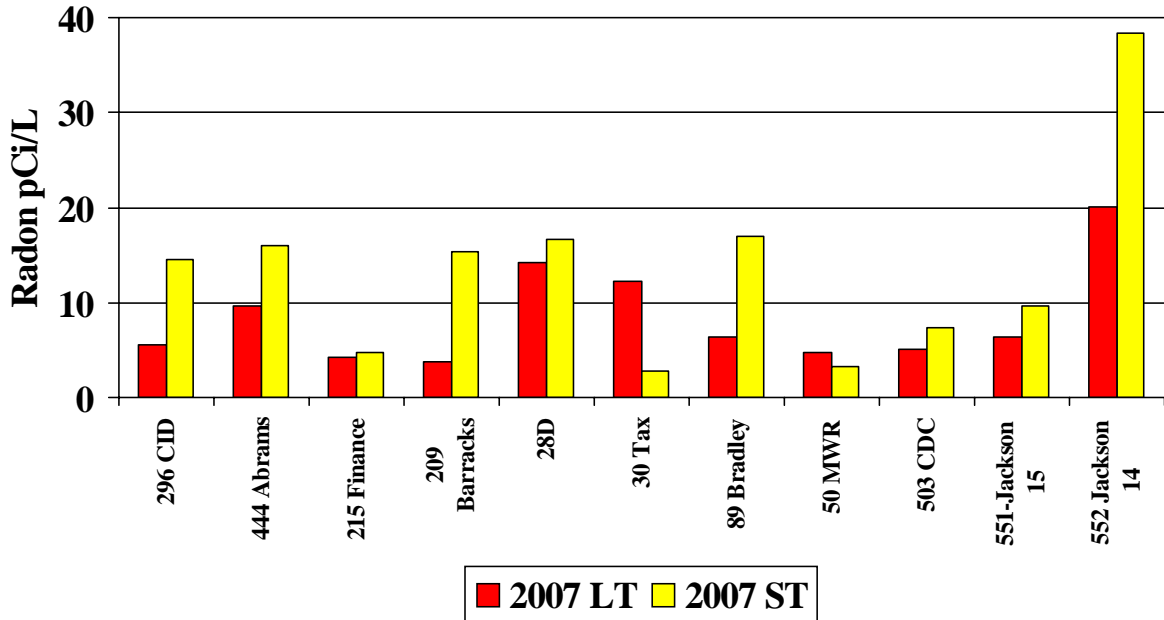
**Figure 2: Comparison of Short-Term Measurements to Most Recent Previous Long-Term Measurements**

The results of the short-term tests are provided in Figure 2 with a comparison to the most recent long-term tests conducted by the USACG. Note that data for building 505 (school) is excluded from this graph as it is provided later in the report and that the locations of the follow-up short-term measurement for buildings 209 and 30, although on the same level of the building, are not in the same room or location as the initial test due to room access issues.

As can be seen from the data in Figure 2, radon levels continue to be near the levels previously measured and in many cases are higher. The fact the recent short-term measurements are higher should not be interpreted as the radon levels are increasing in these units, but rather reflects the cooler weather conditions (i.e. less open window ventilation and higher stack effect) experienced at the time the short-term measurements were conducted that would tend to increase short-term radon levels. However, they do certainly confirm that indoor radon levels can be elevated at the Schweinfurt facility.

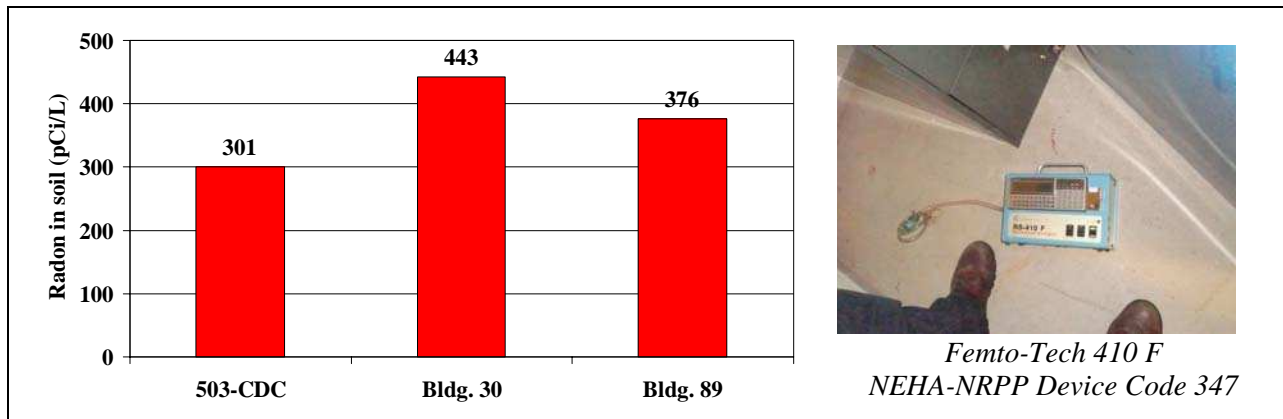
**Figure 3: Soil Gas Samples**

At three locations soil gas measurements were made by drilling a hole through the concrete slab of a building and immediately extracting air from the underlying soil to measure its radon activity. The results of these measurements are shown in Figure 3.

The soil gas measurement values should not be interpreted as the potential indoor radon levels within the rooms above which the measurements were taken, but rather that a significant potential for elevated indoor radon levels exist in buildings situated in the Schweinfurt region due to elevated radon in the underlying soil.

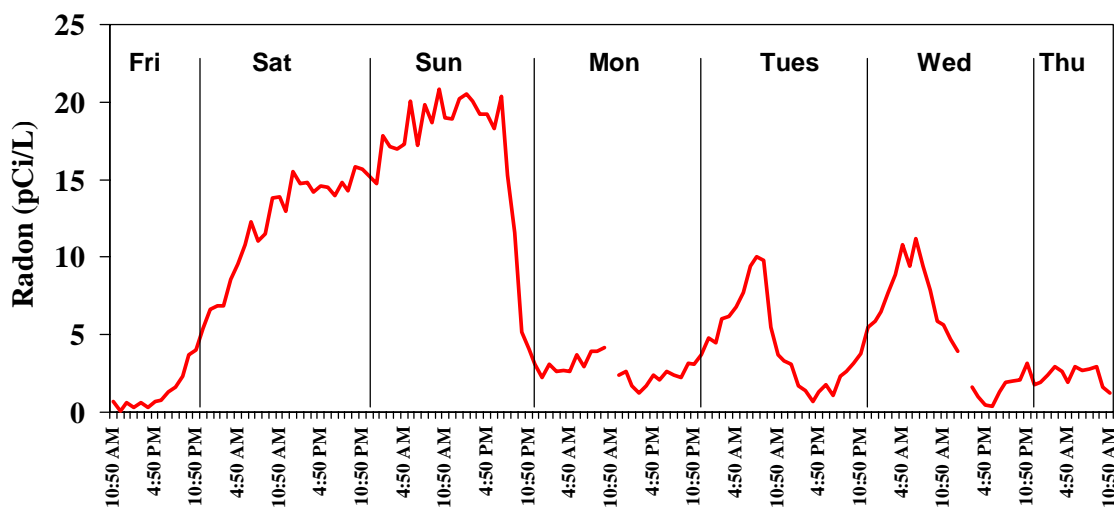
**Figure 4: Hourly Variations – Room 23 Schweinfurt School**

As indicated previously, indoor radon levels can vary as a function of interior vacuums and ventilation rates. To assess the magnitude of these variations, a continuous monitor was deployed in Room 23 of the Schweinfurt Elementary School over a long weekend and for two subsequent school days. The data is provided in Figure 4. In interpreting the data, it should be noted that school was not in session on Saturday Sunday or Monday (school holiday). However, workmen and teachers did enter the school on Sunday and Monday.

The significant increases and decreases noted in Figure 4 are typical of situations where fresh air make up or ventilation is increased during occupied periods of time. One can clearly see a drop in radon levels when the school is occupied and teachers open exterior windows as well as a marked increase during the evenings and weekends when windows are typically closed.

Other than exhaust fans in restrooms there is no mechanical ventilation system at this school. The means by which occupants can obtain fresh air is by manually opening exterior windows, which teachers have been instructed to do for an indeterminate amount of time each morning. It should also be noted that this test was conducted in October 2007 when weather was cool but not cold, thus allowing for open window ventilation without severe drafts in the classrooms. It is likely that during wintry periods when windows would less likely be opened, higher radon levels during occupied periods would be observed than what is indicated by this four day measurement.

- As indicated in Figure 4 on page 13, higher radon levels exist during unoccupied hours and although the levels shown in Figure 25 may be alarming, the actual exposure to teachers and students is likely lower than indicated by long-term, integrating measurements.

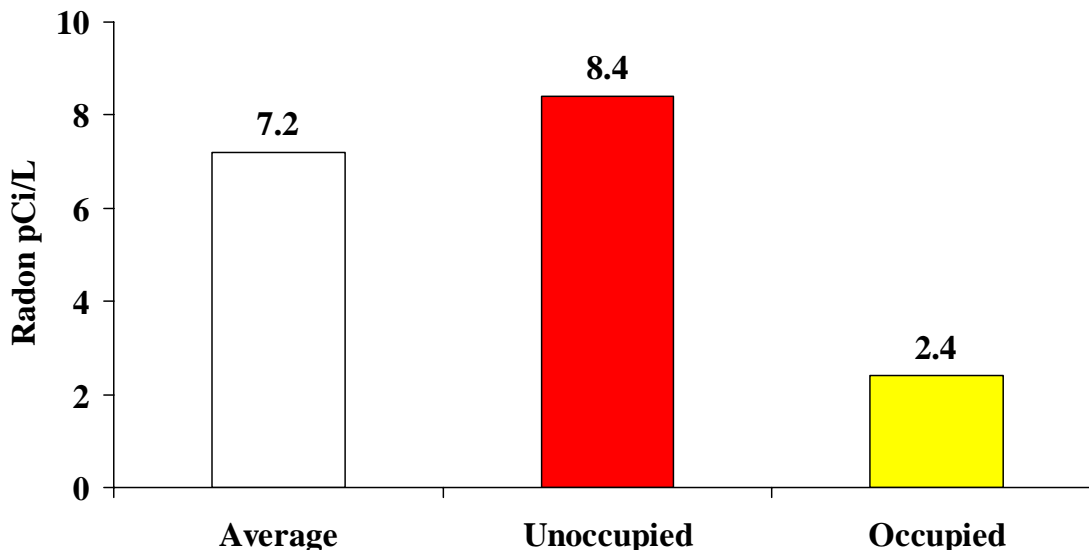
**Figure 5: Occupied to Unoccupied Averages –Schweinfurt Elementary**

Figure 5 provides a graphical comparison of radon exposures during occupied versus unoccupied periods for the test that was conducted in Room 23. As can be seen from this data, although the average exposure is indeed above 4.0 pCi/L, the exposure to children and teachers during occupied periods is significantly lower than would be indicated by an integrating measurement that does not distinguish between unoccupied and occupied conditions. This is due to the higher

levels typically found during unoccupied periods (lower ventilation) and the fact that the building is unoccupied the majority of the time (evenings and weekends).

The data in Figure 5 suggests a bias associated with integrating measurements to be towards radon levels experienced during unoccupied periods of time. This bias is likely to exist with the long-term measurements that were conducted during the initial and follow-up survey. This is not to suggest that radon reductions in the school should not be addressed, but rather that actual exposures may not be as high as what previous long-term measurements would suggest.

One could also interpret the data in Figure 5 as to the effect that ventilation can have where fresh air make-up with proper temperature and humidity conditioning for comfort was controlled. However, in the absence of a central air handling system that would allow for economical management of fresh air make-up, reliance upon manual opening or closing of windows will provide variable and unreliable reductions, especially during extreme cold or hot weather conditions.

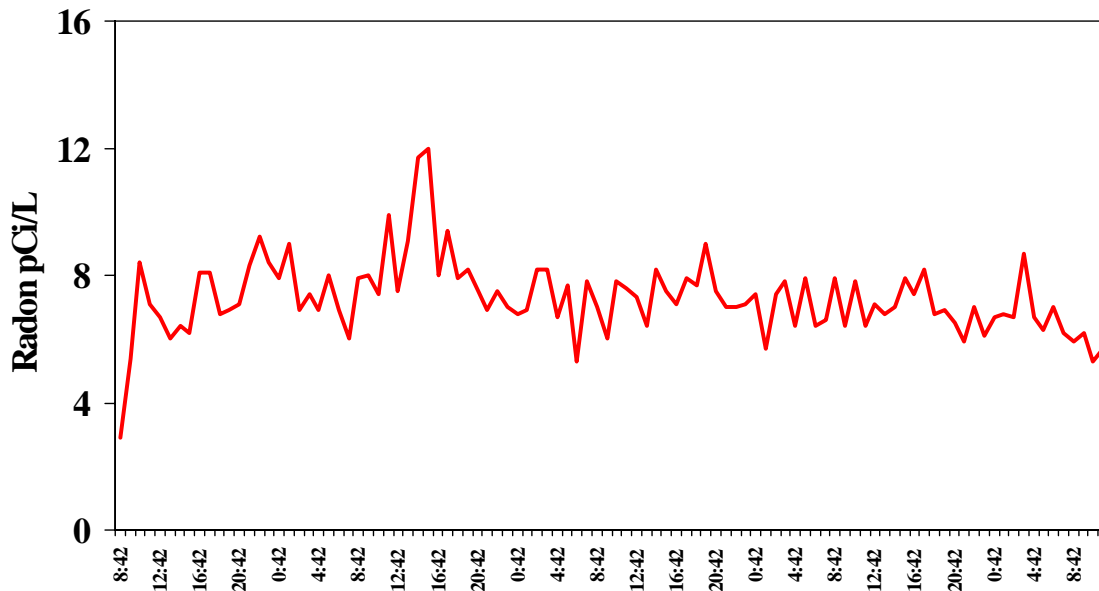
**Figure 6: Hourly Variations in Room with No Ventilation (Bldg 503)**

A similar hour-by-hour measurement was also conducted in a lower level room of Building 503 Child Development Center and over the same period as the test was conducted in the Schweinfurt Elementary School. The data provided in Figure 6 shows much more consistent radon levels. This is due to the fact that this particular room has no windows nor means for ventilation that can reduce radon levels when open.

In essence, the results of the continuous monitor tests point out the beneficial effect that fresh air make-up can have on reducing radon levels during occupied periods. However, if this ventilation cannot be economically provided then other reduction measures need to be considered.

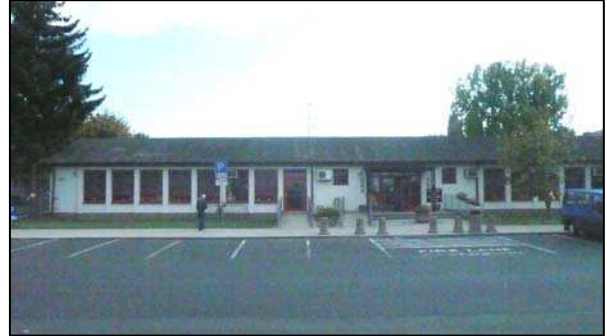
Building 503 is a daycare center and is single story slab-on-grade structure, with a portion of the front section of the structure built over a basement.

The primary focus with respect to radon concerns for this building was Room 2 located in the basement room which is presently used for storage but has historically also functioned as an office.

Previous work conducted by the USACE involved augmenting indoor air supplied to the basement office area in combination with additional building exhaust from a utility room (see Figure 17). According to subsequent radon measurements, the temporary fix is not adequately reducing radon levels.

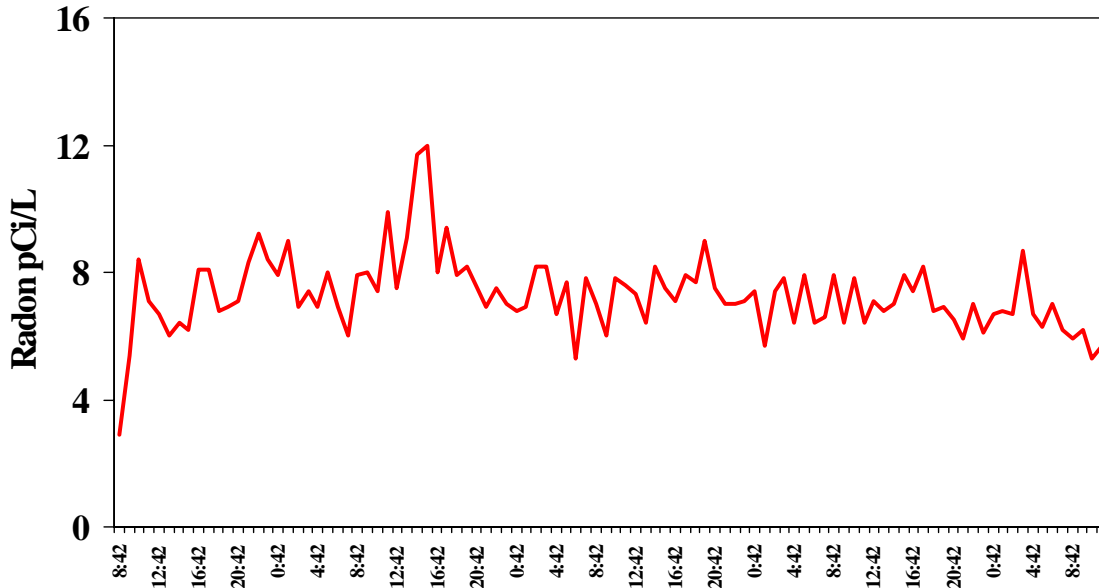
**Figure 15: Hourly Variation in Room #2 with No Ventilation (Bldg 503)**

Hourly measurements of radon in this room are provided below and, as has been discussed previously in 2.1.3.2, indicate a fairly constant radon level which is indicative of a lack of ventilation into this room.

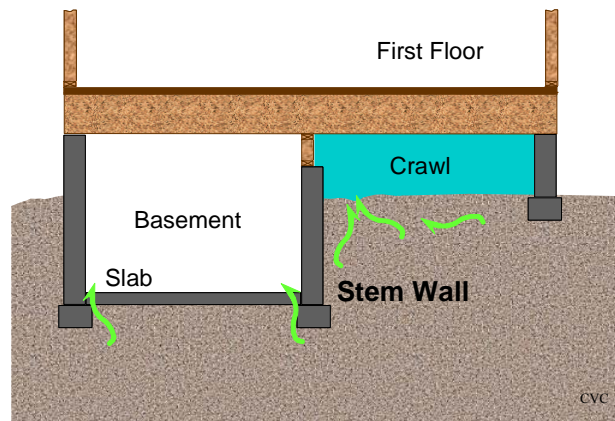
**Figure 21: Duplex Unit Foundation Schematic**

Diagnostics for these two buildings consisted of visual observations and grab radon samples. The most notable feature of these buildings is that in addition to the footprint of the buildings having a finished basement with laundry room and office, there is an earthen floor crawlspace area adjacent to the basement and also under the first floor living area as illustrated in Figure 21.

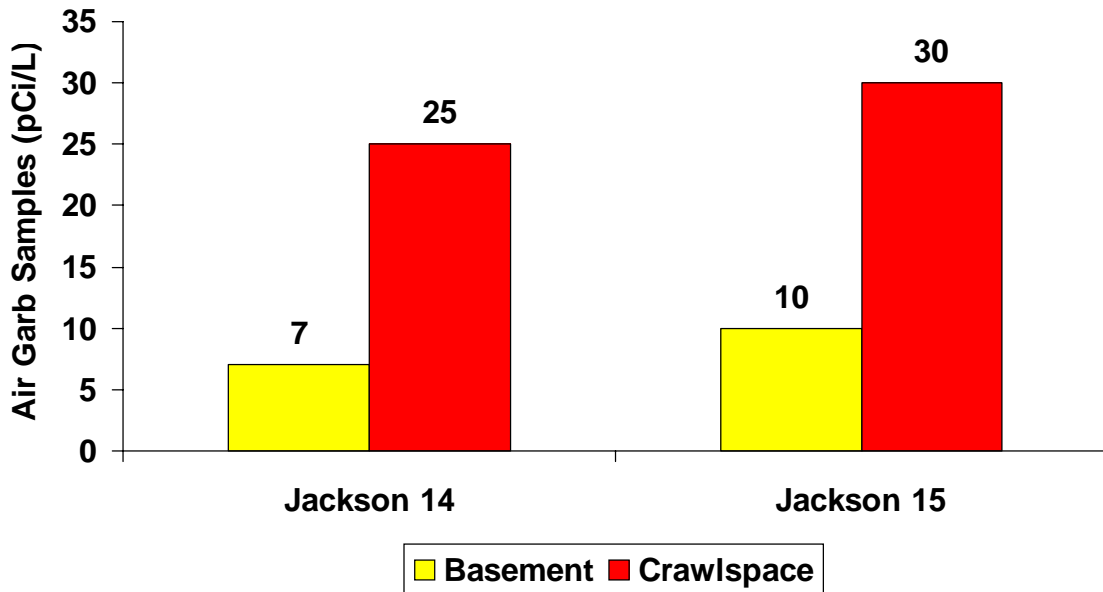
**Figure 22: Crawlspace Grab Samples - Duplexes**

Within the crawlspaces of the residential housing Jackson 14 (Bldg. #551) and Jackson 15 (Bldg. # 552) radon concentrations of 25 pCi/L and 30 pCi/L respectively were measured. The results of the comparison of radon in air within the crawlspaces relative to the adjacent basement areas (see Figure 22 in Appendix A) point out the major role played by these crawlspaces with respect to radon entry. Due to the higher concentration within the crawlspaces it is likely that elevated radon concentrations are not only found in the basements, but also in living spaces above.

The crawlspace area was accessed from a small hatch located within the basement area through which radon grab samples could be taken from the air space within the crawlspace. Note that grab samples are quick samples that provide an indication of relative strengths of radon sources. The results of the comparisons of radon in air within the crawlspaces relative to the adjacent basement areas is provided in Figure 22 and point out the major role that these earthen areas are playing in with respect to radon entry not only into the basements, but also into living spaces above them. Photographs of the crawlspace area can be seen in Figure 23

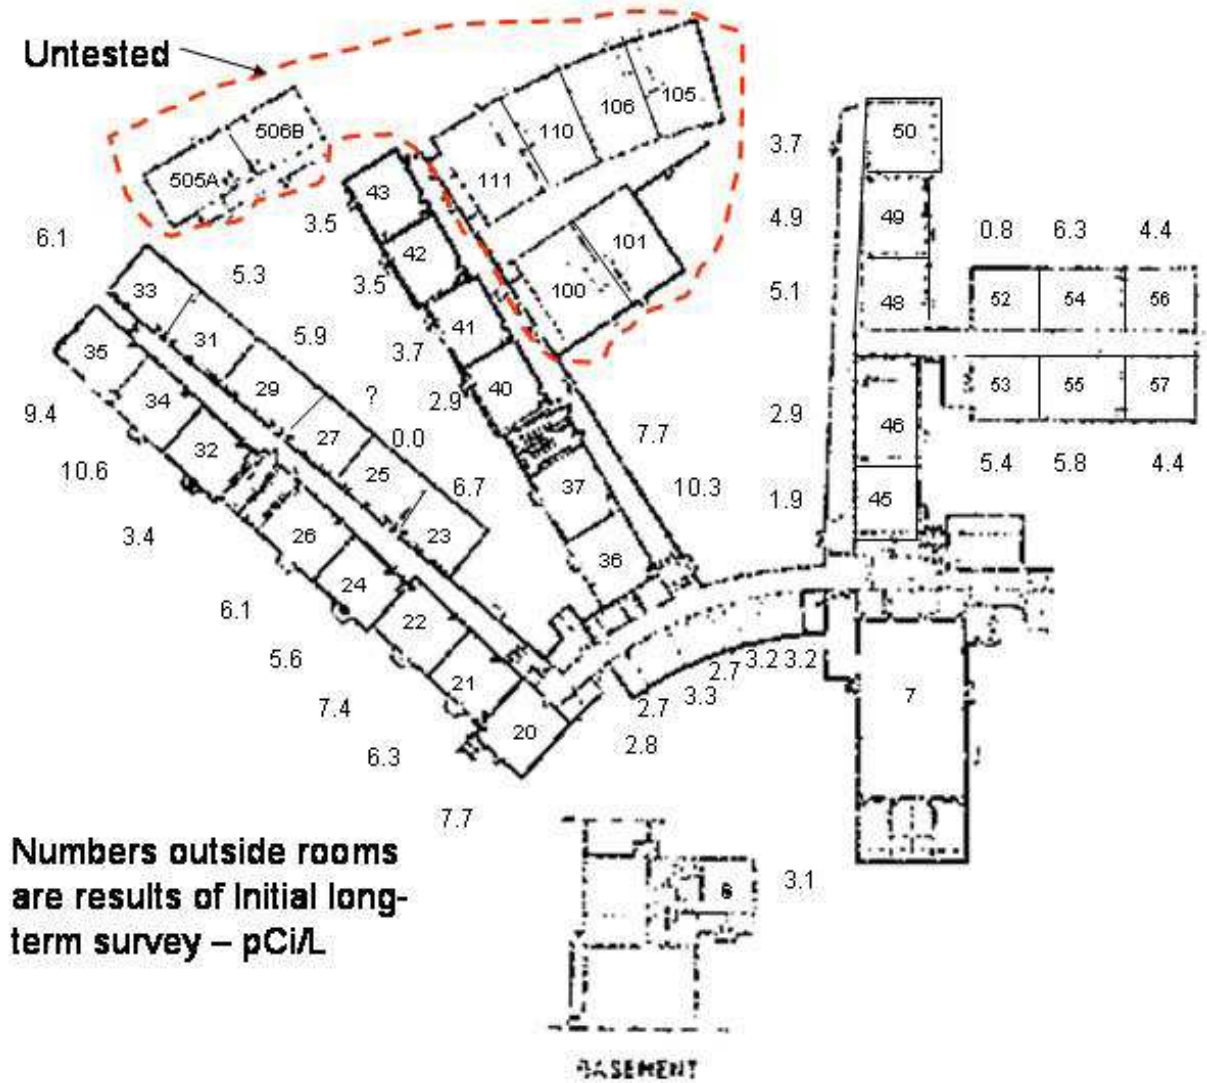
**Figure 25: Diagram of Initial long-Term Tests – Bldg 505**

The results of the initial survey have been plotted in a school schematic depicted in Figure 25. A review of this figure points out several issues:

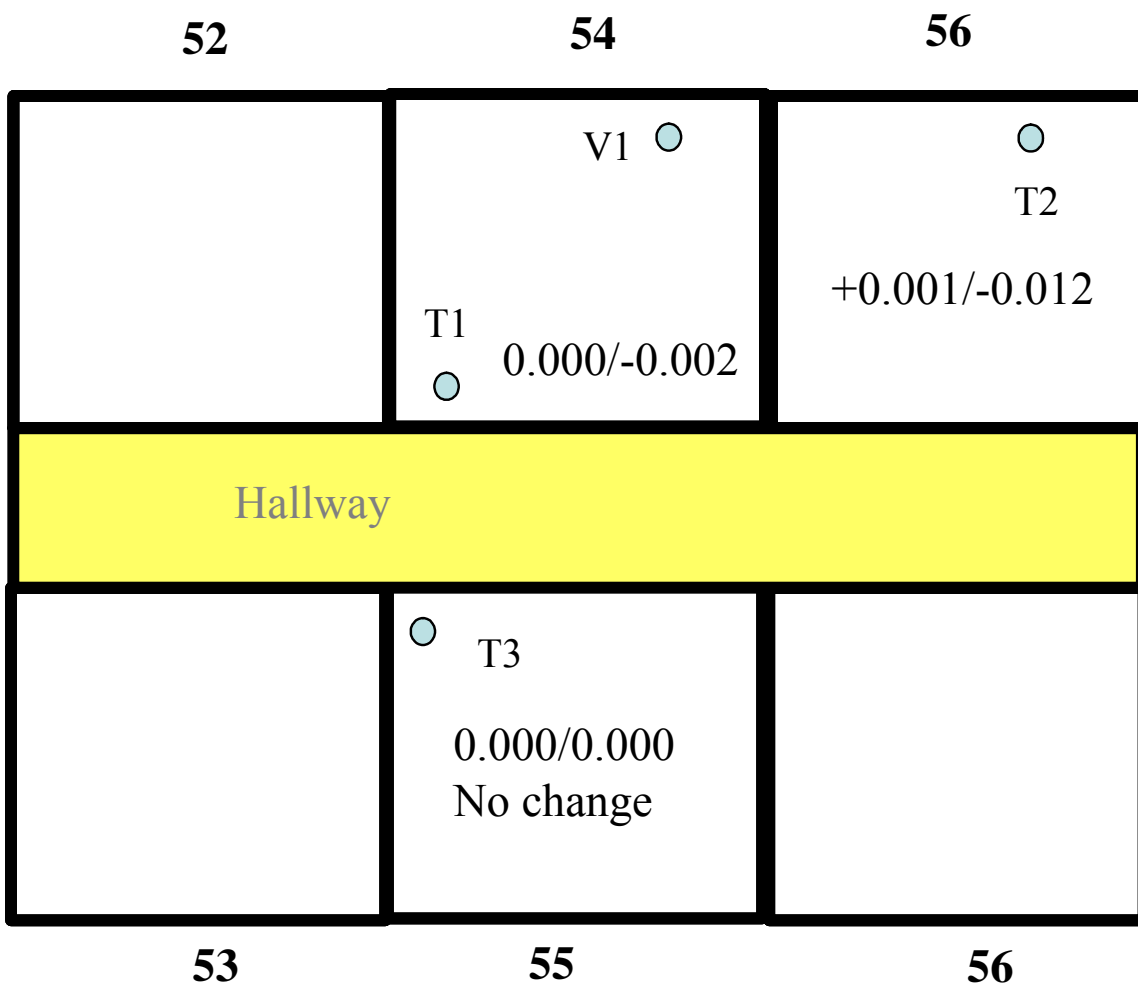
**Figure 26: ASD Diagnostics Bldg 505**

In addition to hourly measurements made in Room 23, diagnostics were performed to determine the efficacy of an active soil depressurization system. These tests were conducted in the Plan North section of the building (Rooms 52-56), the results of which are provided in Figure 26.

In reviewing the results in Figure 26, a vacuum was temporarily applied at the location notes as V1. Sub-slab pressures were measured at holes drilled through the slab at points T1, T2 and T3. The numbers associated with each of the test points are the sub-grade pressures relative to the indoor air with the first number being with the vacuum cleaner OFF and the second with the vacuum cleaner ON. This simple test allows one to determine the possible area of influence that a single point suction system could have.

As can be seen from the data in Figure 26, a single suction point applied at V1 not only can beneficially impact the slab under the room it in which it is applied but also under an adjacent room. However, it did not seem to impact the classroom across the hallway.

It should be noted that the air flow being pulled by the vacuum cleaner was in excess of 100 cubic feet per minute which is the maximum capacity of the vacuum cleaner utilized. The significance of this is that it is possible that a larger area of influence perhaps is achievable with a fan system with a much higher air flow capacity than the vacuum cleaner utilized for the diagnostics.

As demonstrated by the field diagnostics a suction system is capable of treating multiple rooms. To assure this capability, split suction points should be installed where soil gases are drawn from two sides of a building column from the exterior of the building. This will allow the systems to be external to the building, however in several cases this will require removal of sidewalk or asphalt to allow the contractor to penetrate below the slab.
